SUBJECT: LEAD RISK ASSESSMENT AND MOLD
SURVEY FOR HONOLULU HALE

The enclosed subject report, dated February 24, 2012, prepared by Muranaka Environmental Consultants, Inc., has been accomplished and is transmitted for your information and use. This report does not include the Department of the Corporation Counsel which was covered in a separate report.

Photo Log
Honolulu Hale
Lead Paint Risk Assessment and Mold Investigation
MEC Project No.: 2011-0044
July 2011

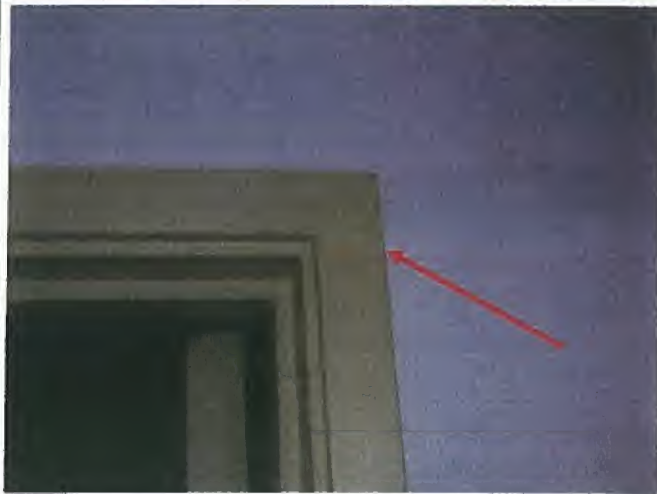
Photo No. 1:
Evidence of mold growth on the wall, door and doorframe in the Custodian and Maintenance Office Area in the Basement. Similar evidence of mold growth was observed in various areas of the basement.

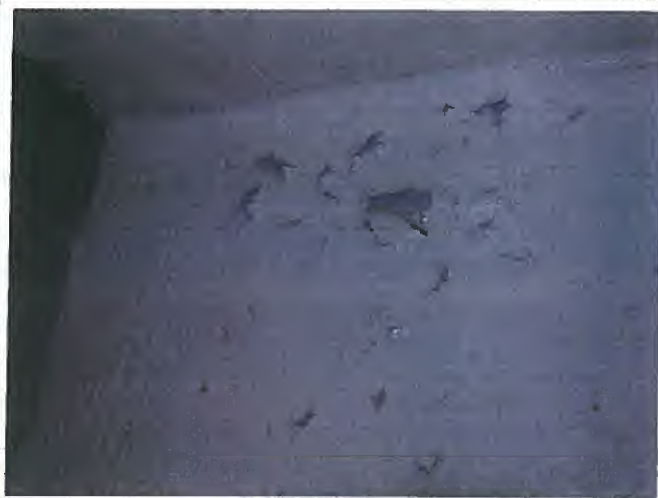
Photo No. 3:
View of flaking paint on the wall in the hallway at the Custodian and Maintenance Office area. Flaking paint was observed at various locations throughout the basement.

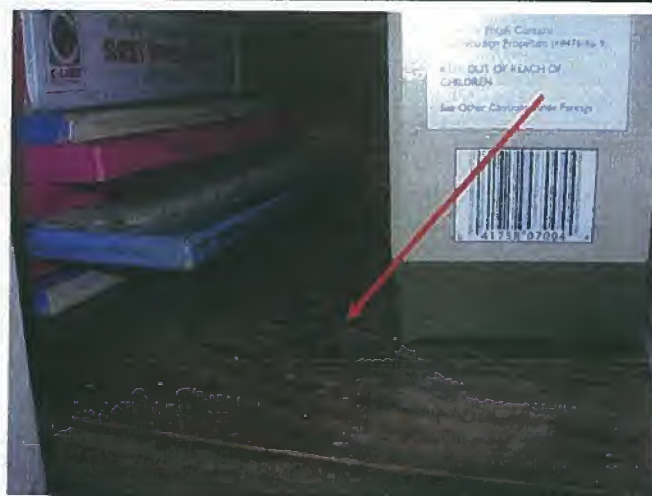
Photo No. 4:
Evidence of mold growth on the shelving in the Maintenance Office. Similar conditions were observed on wooden shelves at various locations throughout the basement.

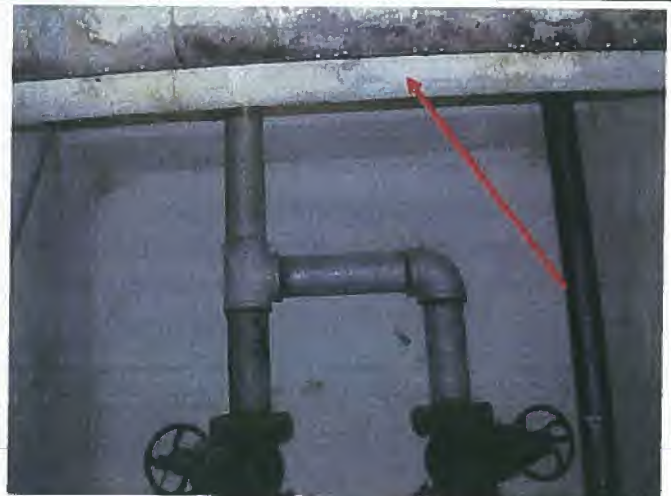
Photo No. 7:
Evidence of mold growth on the pipe insulation in the pump room located in air handler room #2. Similar mold growth was observed on pipe insulation in the other air handler rooms in the basement.

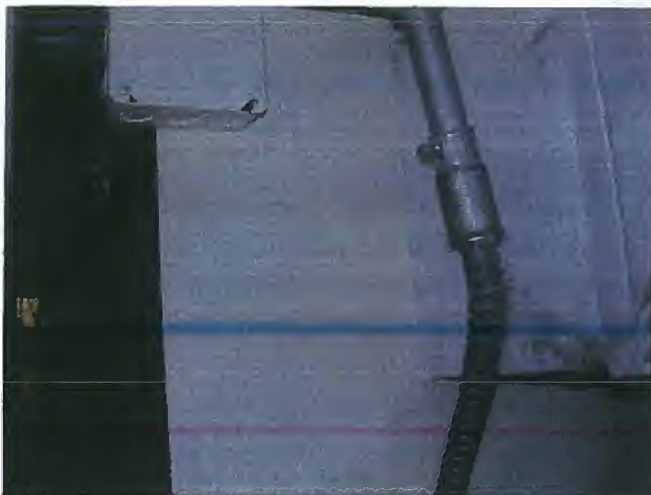
Photo No. 8:
Evidence of mold growth on the wall in air handler room #1. Similar mold growth was observed at various locations throughout the basement areas.

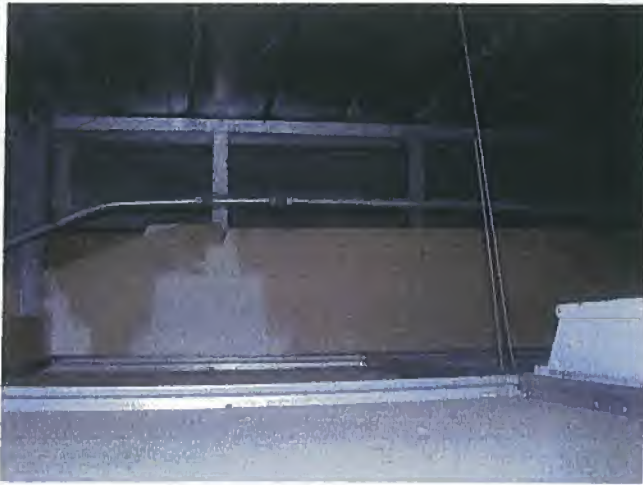
Photo No. 9:
View of the bare metal ceiling above the ceiling grid in Office 100-City Clerk, Administration, Election.

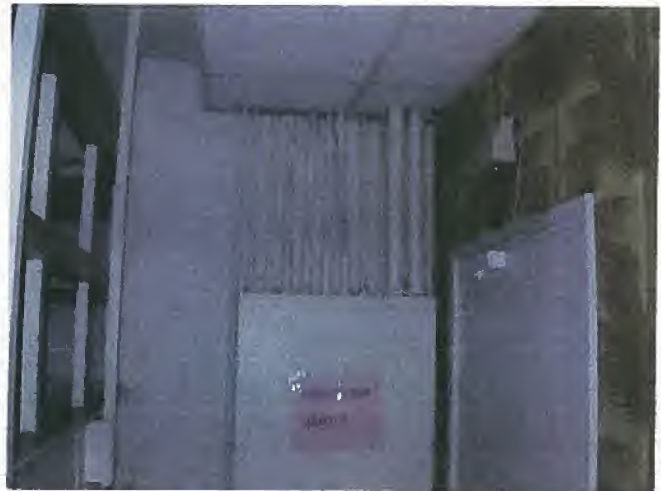
Photo No. 10:
View of flaking paint on the conduit above the electrical panel in the Office 100-City Clerk, Administration, Election.

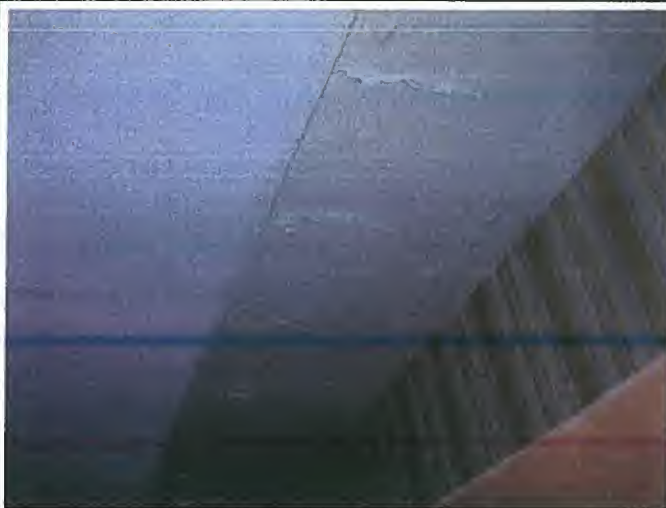
Photo No. 11:
View of flaking paint on a concrete beam in Office D100. Similar flaking paint was observed at various locations throughout the Ground Floor.

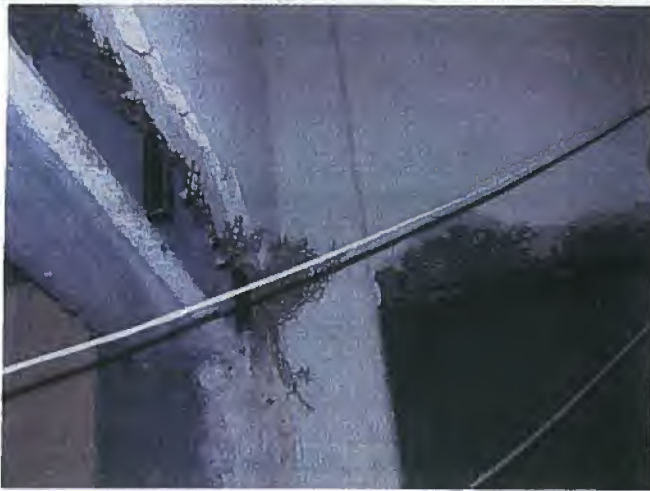
Photo No. 12:
View damaged walls above the ceiling grid in Office E100. Similar damage to the walls were at various locations throughout the Ground Floor.

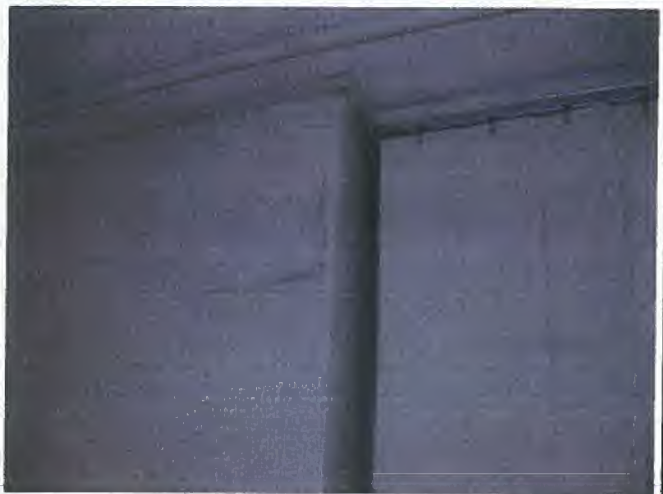
Photo No. 13:
View of flaking paint in Office 101, north of Office 100. Similar flaking paint was observed at various locations throughout the Ground Floor.

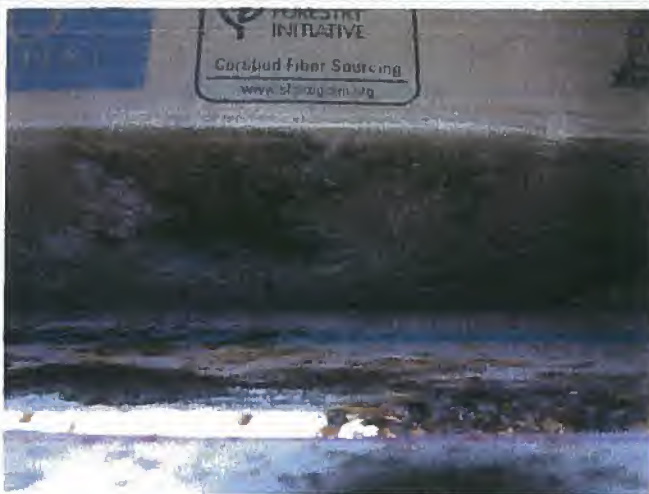
Photo No. 14:
View indicating evidence of mold growth under a box on the refrigerator in Office 101.

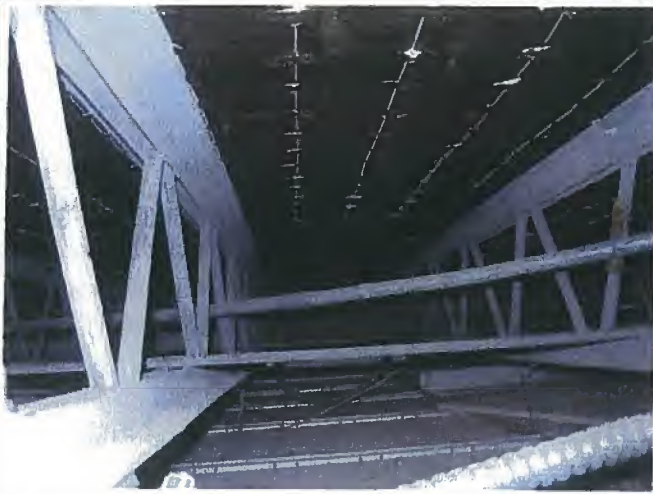
Photo No. 15:
View of the ceiling above the above the suspended grid. Black felt was attached under the concrete ceiling, which extended throughout most of the Tax, Treasury and Purchasing area.

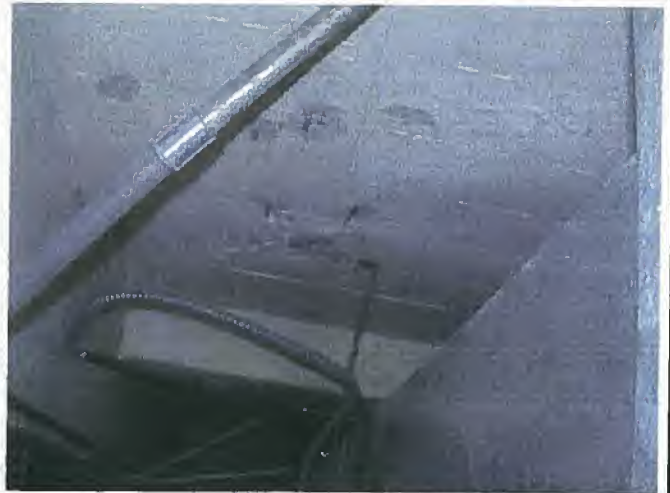
Photo No. 16:
View of flaking paint on the ceiling and around anchors attached to the concrete. Similar flaking paint was found throughout various locations of the Ground floor.

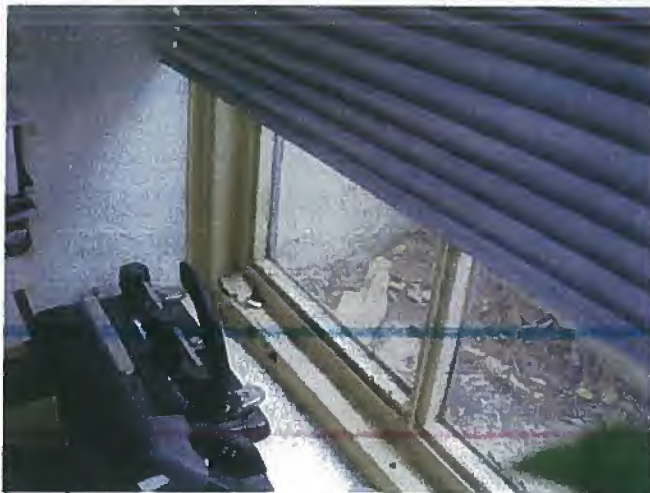
Photo No. 17:
View of flaking paint around the window casing. Similar flaking paint was found around window casings at various locations throughout the Ground Floor.

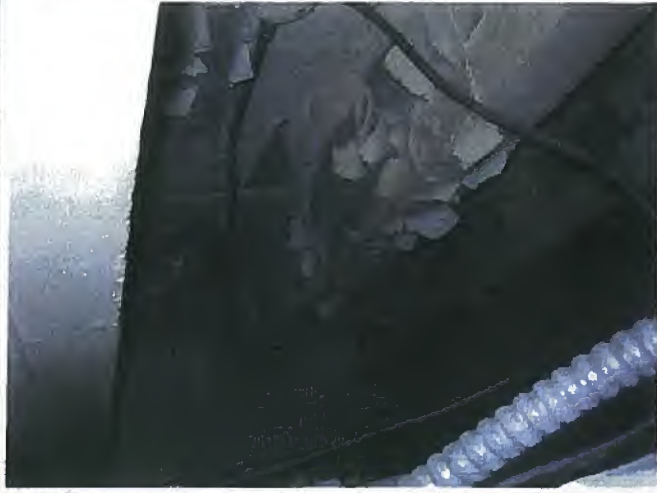
Photo No. 18:
View of flaking paint on the ceiling above the suspended grid in Office 115-1A. Paint chips were on top of the ceiling tiles. Similar flaking paint was observed at various locations throughout the Ground Floor.

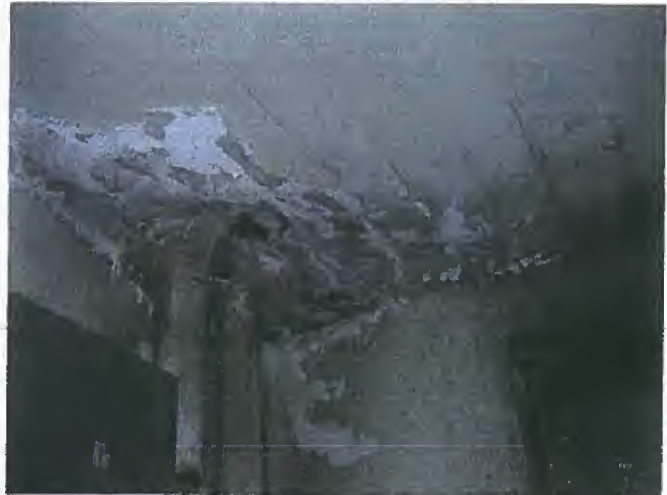
Photo No. 19:
View indicating evidence of mold growth and flaking paint in Room 115-10 (Air Handling Room) on the ceiling.

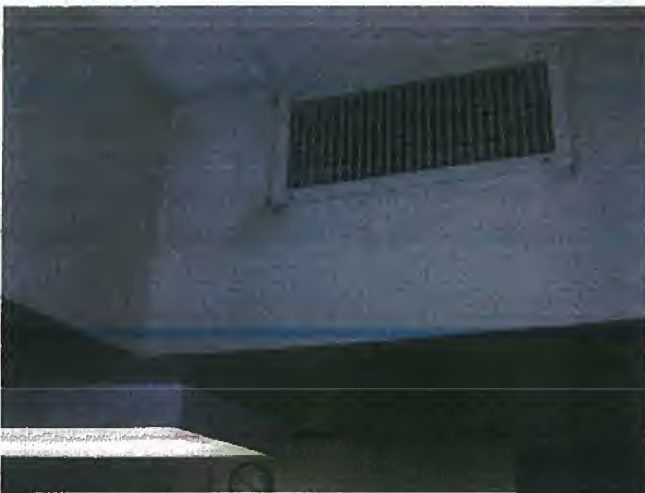
Photo No. 20:
View indicating evidence of mold growth on the soffit for the air conditioning duct work. Similar mold growth was found on the ductwork throughout the Tax, Treasury and Purchasing area.

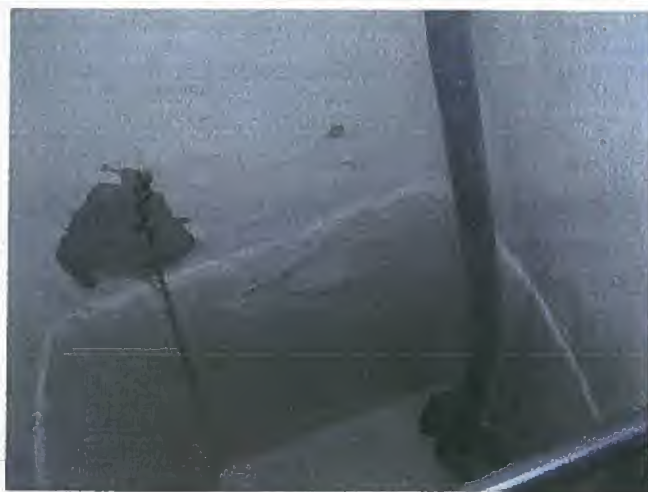
Photo No. 22:
View of flaking paint on the concrete ceiling and around the anchor attached to the ceiling. Similar flaking paint was observed at various locations throughout the 2nd Floor.

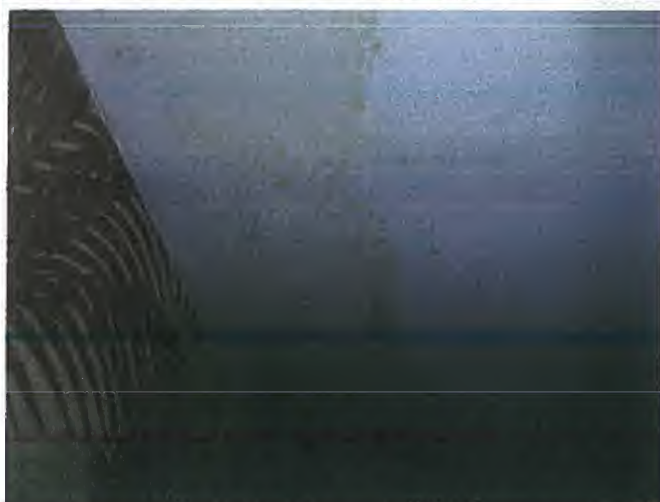
Photo No. 23:
View indicating evidence of mold growth on the gypsum ceiling in the hallway in the 2nd Floor Purchasing Office.

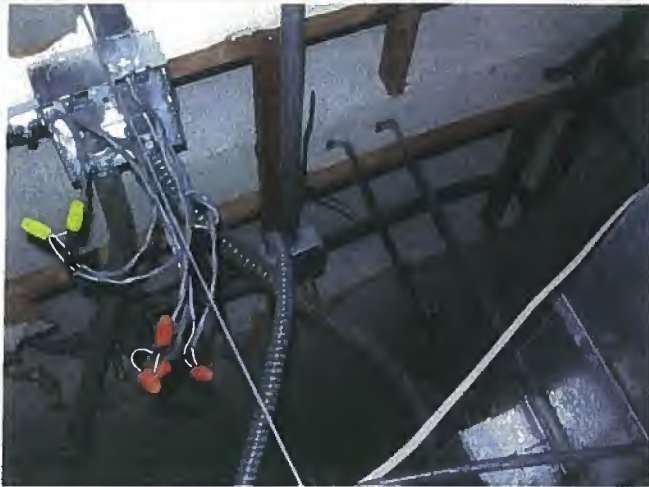
Photo No. 24:
View of the damaged ceiling in Office M202 (Conference Room #2). Similar ceiling damage was in the offices along the southern side of the Counsel Member's Offices.

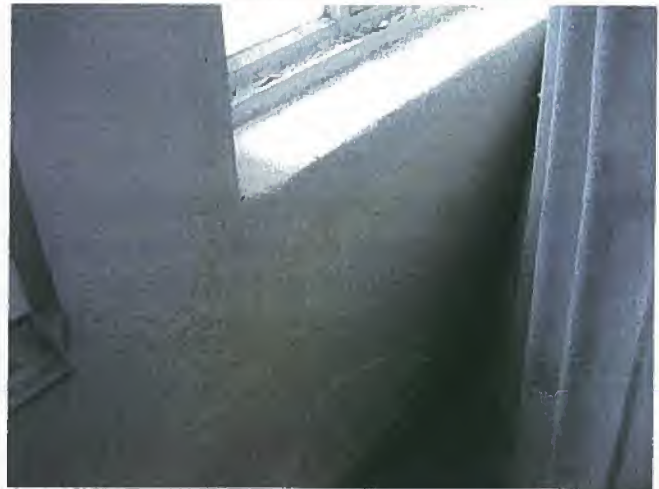
Photo No.25:
View of flaking paint on the window sill and blistering paint on the wall below the window in Office 201-City Council Committee Meeting Room.

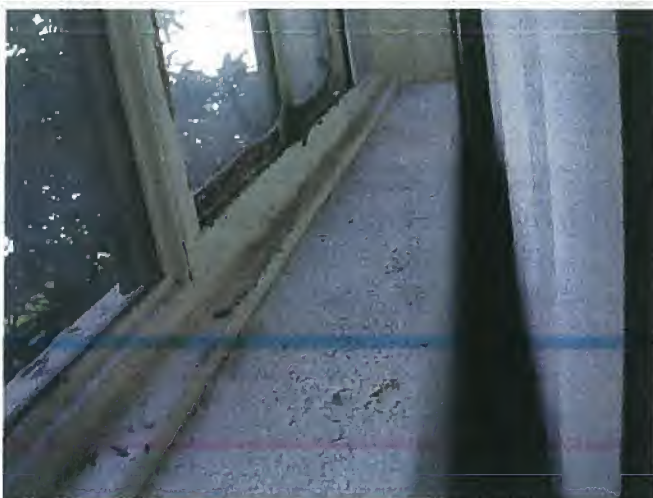
Photo No. 26:
View of flaking paint on the window sill in the Council Services Office. Similar flaking paint was found on window sills at various locations throughout the 2nd Floor.

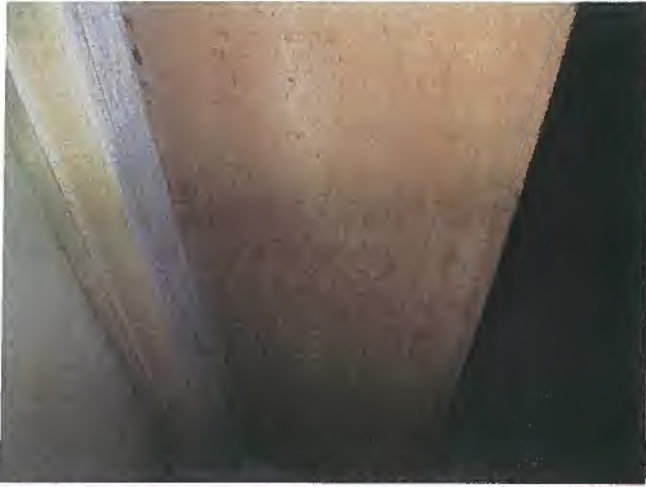
Photo No. 27:
View indicating evidence of mold growth on the wooden shelf in the Council Services Office. Similar mold growth was observed at various locations throughout the 2nd Floor.

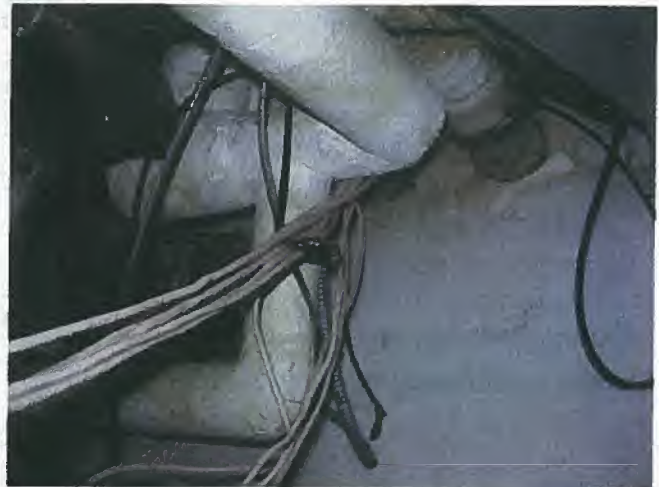
Photo No.28:
View of staining on the gypsum wall and pipe insulation suggesting moisture intrusion or leaking occurred.

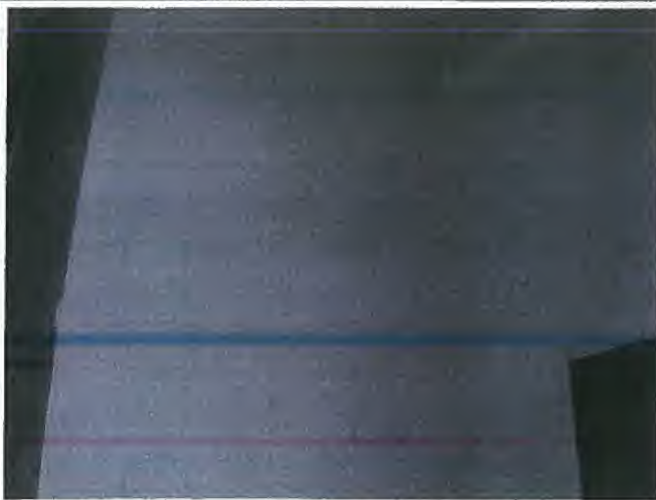
Photo No. 29:
View of gray patches on the wall in the Women's Toilet indicating evidence of mold growth was present.

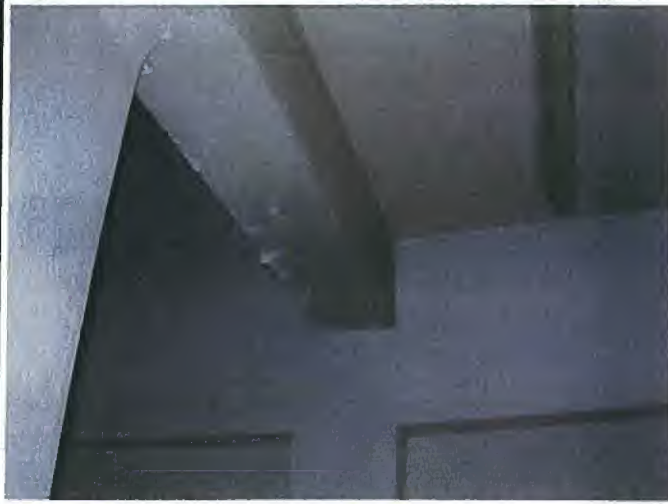
Photo No. 30:
View of flaking paint on the ceiling in the 2nd Floor Hallway Stairwell. Similar flaking paint was observed at various locations throughout the 2nd Floor.

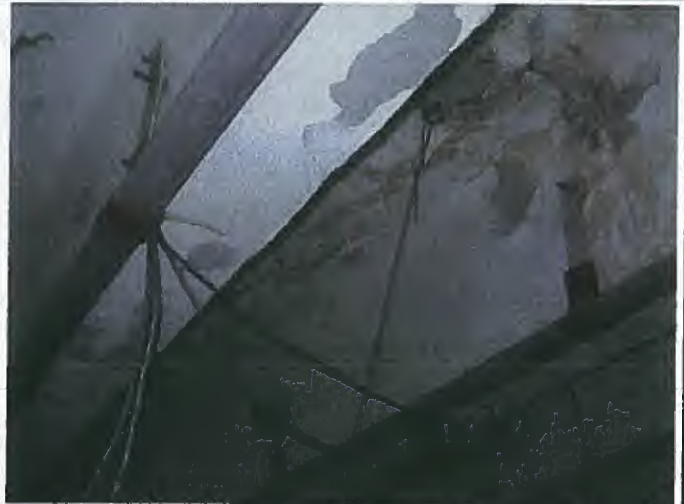
Photo No.31:
View of the ceiling above the suspended grid in the Mayor's Small Office. The paint was flaking and staining suggested moisture intrusion or leaking occurred. Similar paint flaking and staining was at various locations throughout the 3rd Floor.

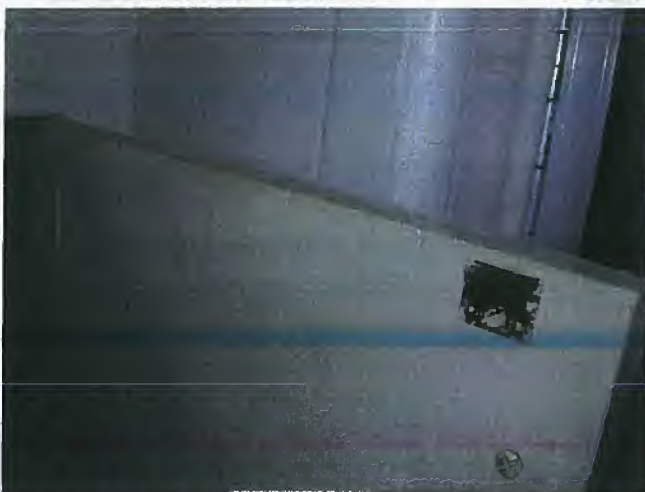
Photo No. 31:
View indicating evidence of mold growth on the door in the bathroom. Similar mold growth was observed on doors at various locations on the 3rd Floor.

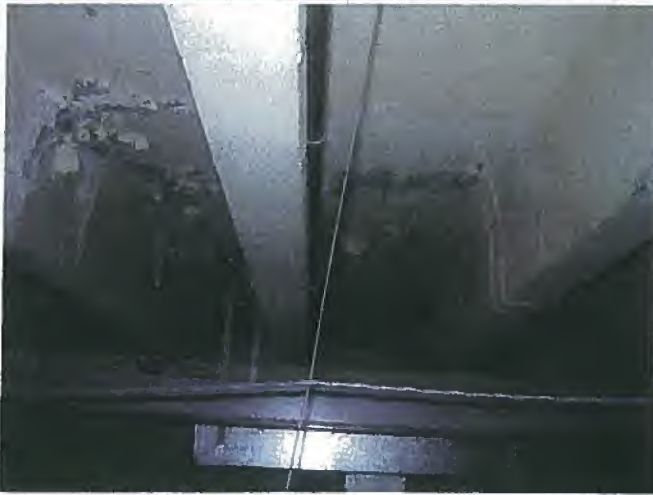
Photo No. 32:
View of flaking paint on the ceiling in Office 301 (Conference Room). Paint chips were observed on the ceiling tiles. Similar flaking paint was observed at various locations throughout the 3rd Floor.

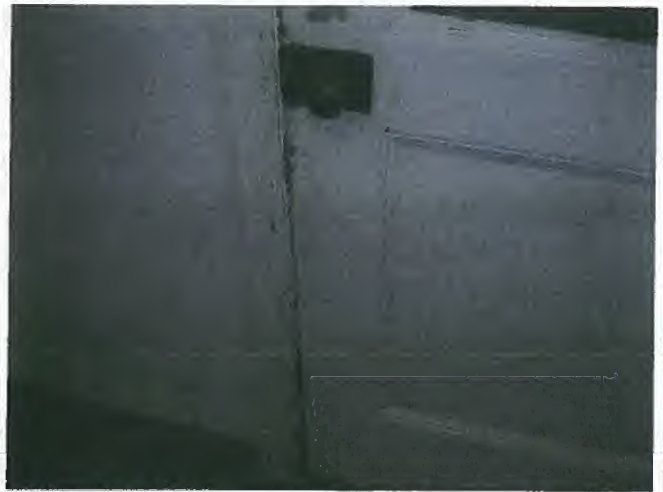
Photo No.33:
View of deteriorated paint at the friction points of the door and doorframe. Similar deteriorated paint was observed at various locations throughout the 3rd Floor.

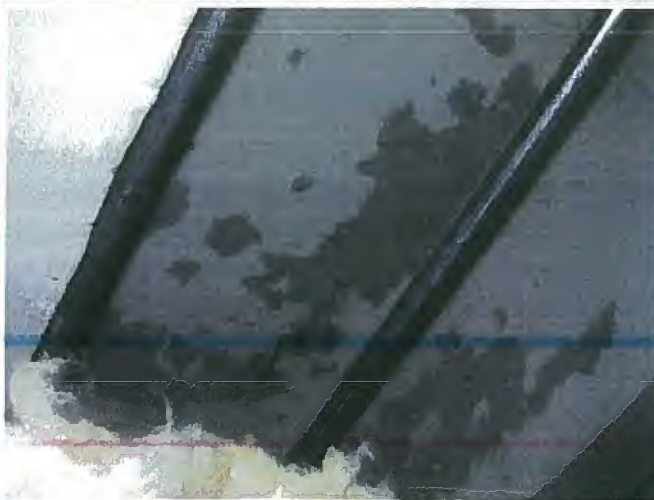
Photo No. 34:
View the paint on the ceiling in the renovated offices on the 3rd Floor. The loose and flaking paint was removed prior to renovations .

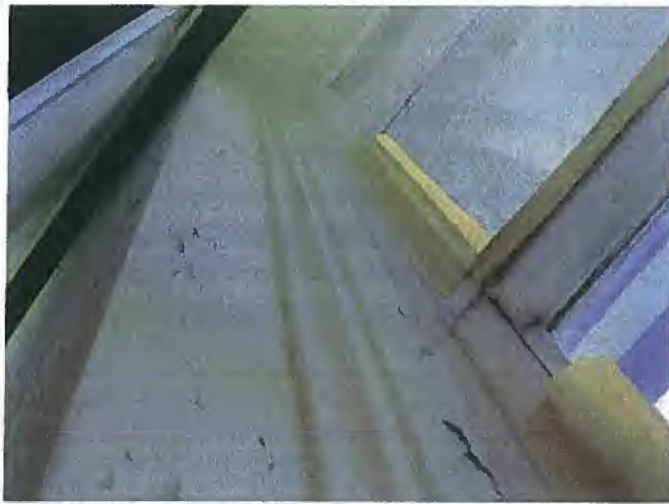
Photo No. 35:
View of a flaking paint on a window sill in the Budget and Fiscal Office on the 3rd Floor. Similar flaking paint was observed at various locations on the 3rd Floor.

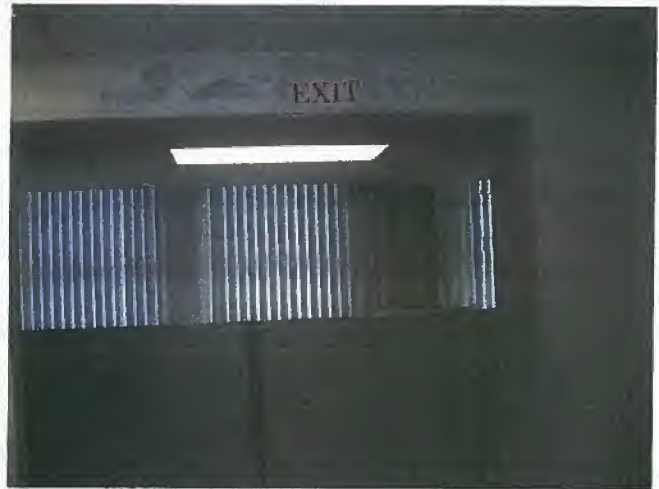
Photo No.36:
View of flaking paint on a wall in the Budget and Fiscal Office. Similar flaking paint was observed at various locations on the 3rd Floor.

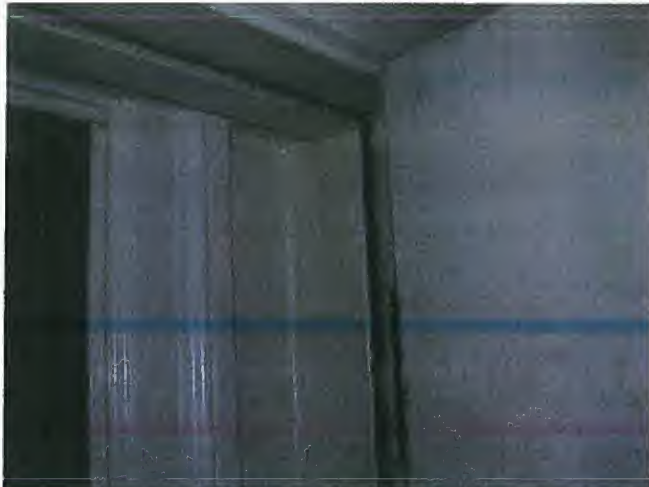
Photo No. 37:
View indicating evidence of mold growth was on the walls, door and doorframe in the Budget and Fiscal Office entrance to their bathroom. Similar mold growth was observed in the bathroom and other areas of the 3rd Floor.

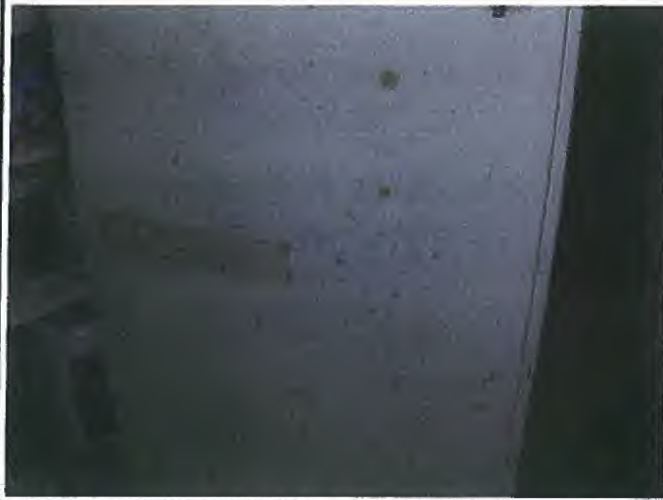
Photo No. 38:
View indicating evidence of mold growth on the wooden cabinets in the 3rd Floor Budget and Fiscal Office. Similar mold growth was located at various locations throughout the 3rd Floor.

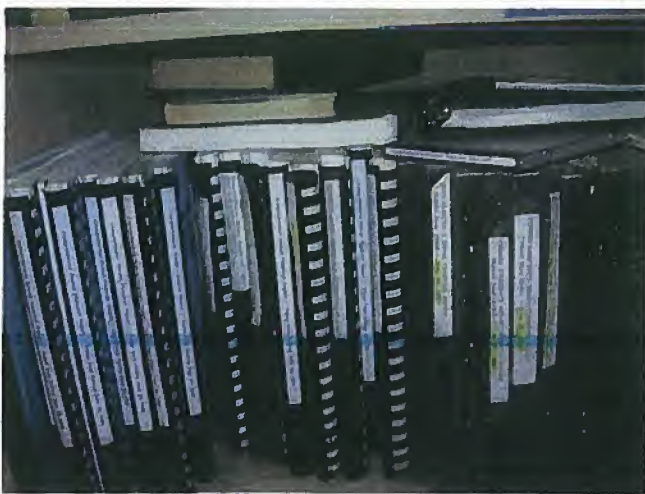
Photo No. 40:
View indicating evidence of mold growth impacting books on a shelf in the copy room of the Budget and Fiscal Office. According to occupants, leaking occurred in the Copy Room.

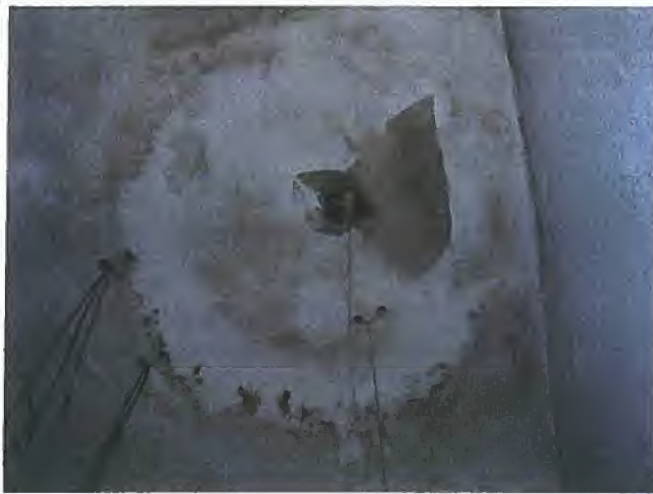
Photo No. 41:
View of staining on the ceiling in Office 401. Staining suggested moisture intrusion or leaking occurred, which may have loosened the paint. Similar leaking was observed at other locations of the 4th Floor.

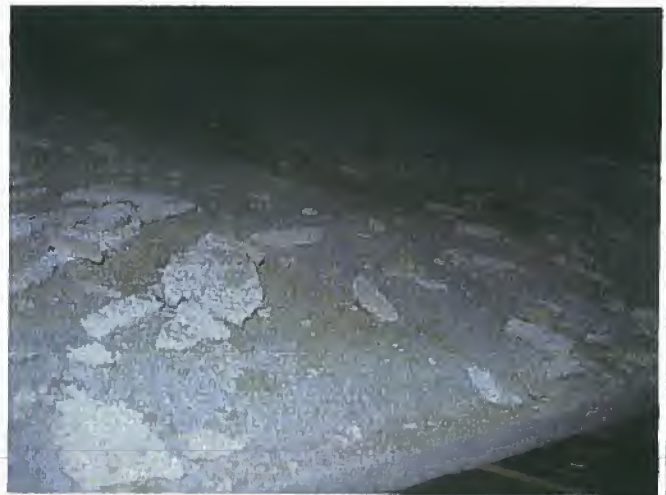
Photo No.42:
View of painted ceiling debris on the ceiling tiles in Office 401. Similar debris from the ceiling was observed in the Office 401 and 402.

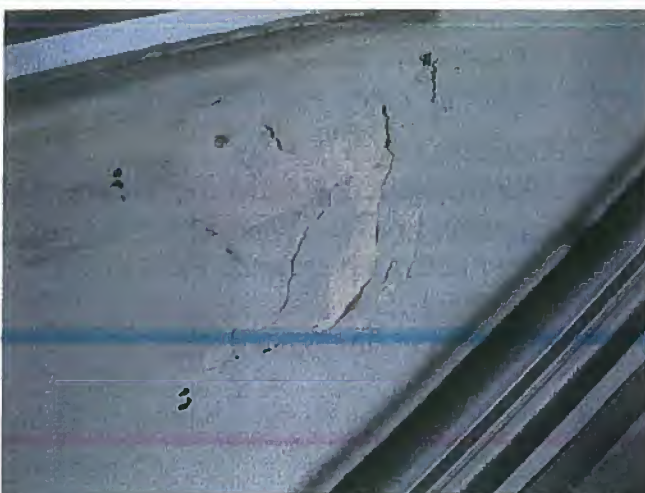
Photo No. 43:
View of flaking paint on the wall in the hallway fronting Offices 402 and 403.

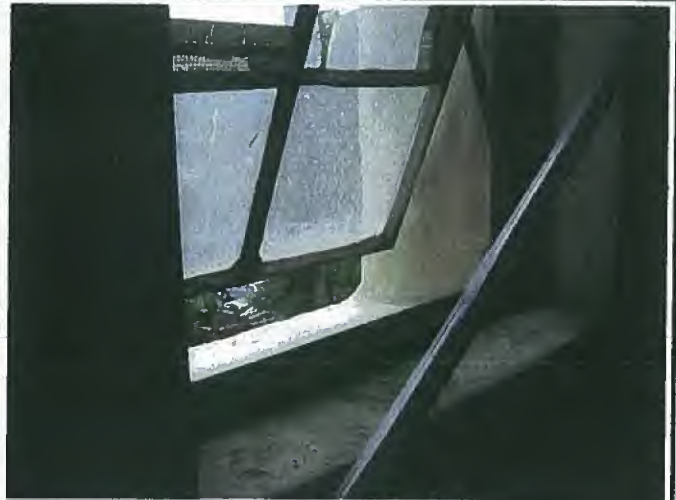
Photo No.45:
View of the flaking paint on the window sill in the common area fronting the Culture and Arts Office.

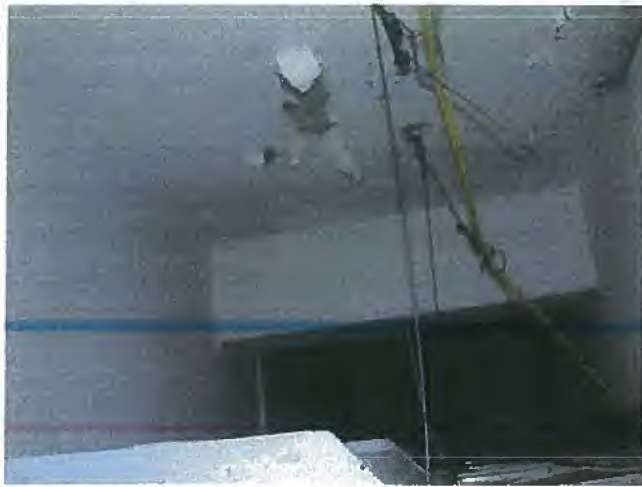
Photo No. 46:
View of flaking paint on the ceiling above the suspended grid in Office 501. Similar flaking paint was observed at various locations in the office.

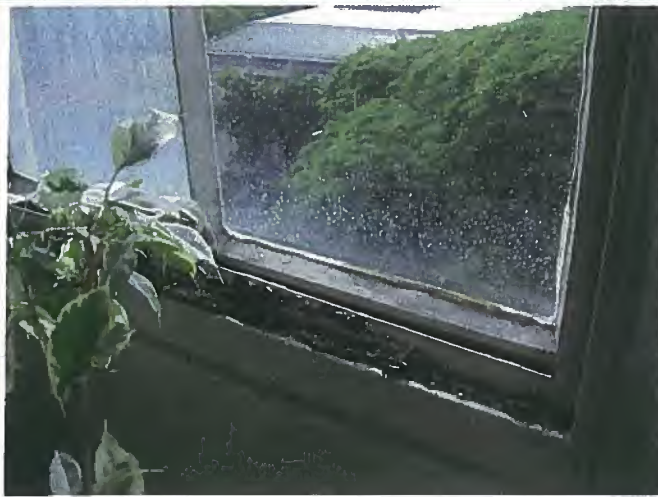
Photo No. 47:

View of flaking paint and rusting on the window casing in Office 601. Similar flaking paint and evidence of rust on the casing was observed on the other window casings in the office.

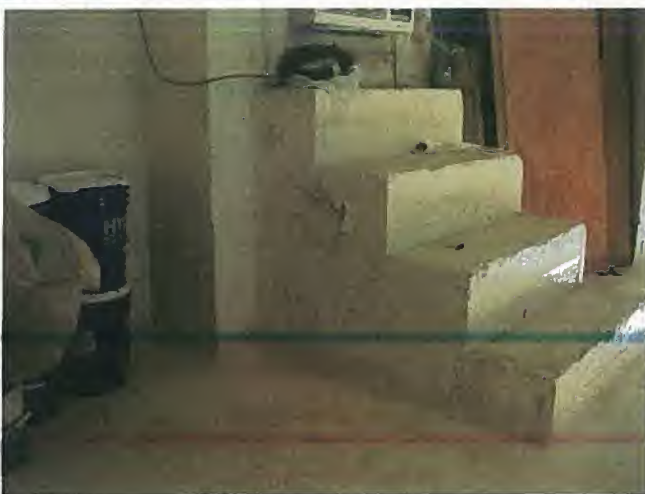
Photo No. 49:

View of flaking paint on stairs in the 8th Floor Office. Similar flaking paint was observed at various locations in the office.
